Application Case Study

Multiple Gases

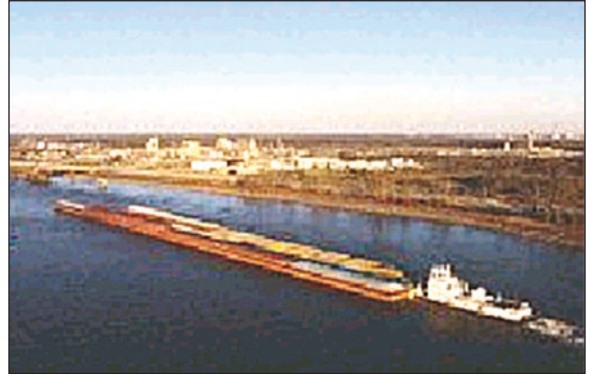
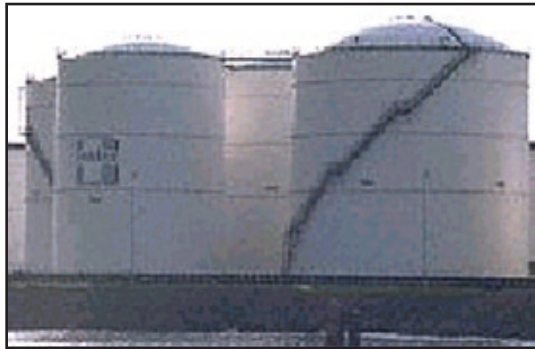
A chemical plant in the southern USA needed a level transmitter for a temporary storage tank that was used for this purpose. Initial discussions indicated that there was a nitrogen blanket on top of the liquid. The tank was 40 feet (12.2m) tall and 60 feet (18.3m) in diameter. At first, this appeared to be an ideal application for this product.

SOR® proposed a U71/BCP for this storage tank. This unit is plenty powerful enough to measure over the required range and a nitrogen blanket is normally not a problem for ultrasonics. However, when the unit was installed it was observed to fluctuate wildly and only occasionally track the liquid correctly.

The echOsonix was not able to track the liquid because of the different gases and their changing composition. An ultrasonic transmitter must know the speed of sound in the medium in order to operate properly. When there are layers of different gases (all with different speeds of sound), it is impossible to accurately measure the overall speed of sound. The echOsonix can compensate for gases other than air, but it must be one gas only and consistent in mixture.

The echOsonix was determined to be the wrong technology for the application. It was impossible to calibrate the unit to provide any kind of stable reading. The U71/BCP was pulled out and an RF transmitter was used in its place. The RF transmitter is working properly and can ignore the changes in atmospheric gases.
